AFATL-TR-67-55

Three Full-Scale Dynamic Crash Tests of a CNU-103/E Shipping Container

Technical Report AFATL-TR-67-55

MAY 1967

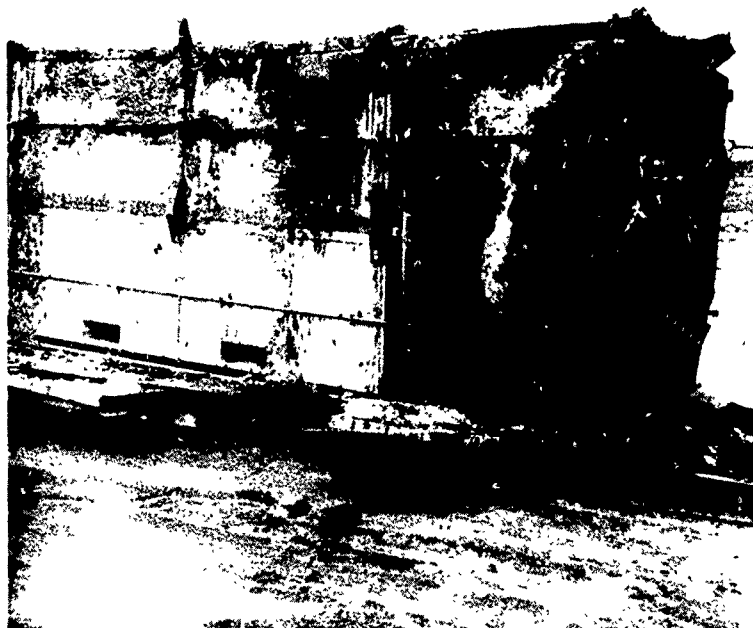
Figure 16. Front Portion of Shipping Container - Test 1.

Extensive fires developed in the aircraft wreckage which required immediate removal of the Shipping Container to prevent unnecessary postcrash fire damage. The forward end of both Shipping Containers looked quite similar after being pulled from the wreckage. Figure 16 shows the container removed from the Test 1 wreckage and Figure 17 shows the container from Test 2. The postcrash fire caused more extensive damage in Test 2 which allowed a view of the crushed aluminum honeycomb shown in Figure 18.

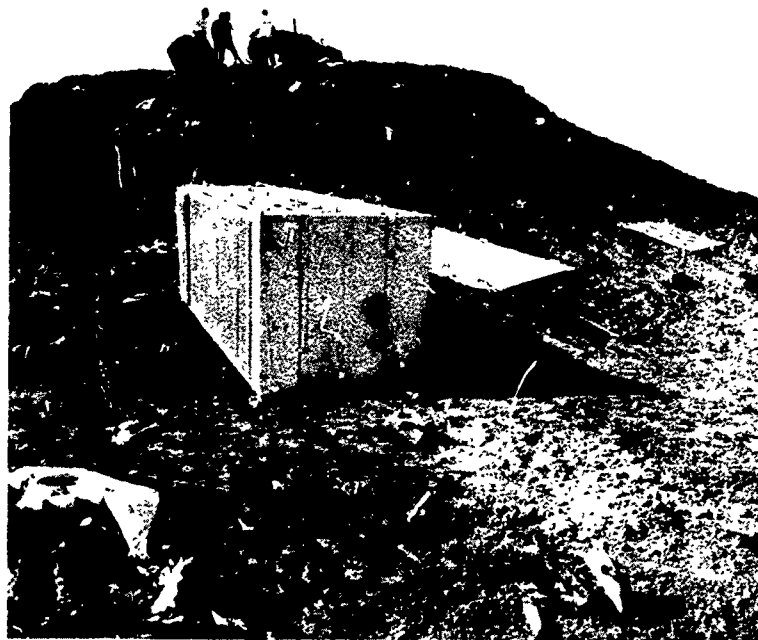
Figure 22. Final Position of Shipping Container - Test 3.

Container during the travel up the front slope of the impact hill. At a point approximately halfway up the impact slope, the aircraft horizontal stabilizer contacted the rear of the container with sufficient force to push the container over the top of the hill. As the container passed over the top of the hill, a slight roll to the right, combined with a slight nose down attitude, developed. This continued until the front edge of the container contacted the earth on the rear slope. The container turned over and came to rest on its right side with the rear of the container forward. Figure 22 shows the final position of the container on the rear slope.

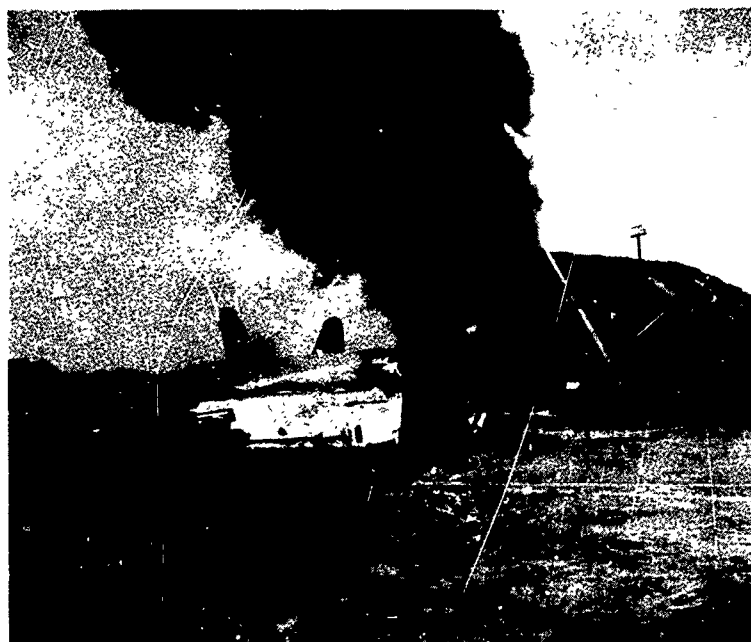
Figure 25. C-119 - Postcrash - Test 1.

Both aircraft were completely destroyed in the impact. Figure 25 shows the first test aircraft immediately after impact while Figure 26 shows a later postcrash scene after the tail booms and Shipping Container had been moved. The wreckage is the entire aircraft except for the above mentioned items and the wing tips. The fire, shown in Figure 25, resulted from a maximum of 50 gallons of oil, 3 to 4 gallons of fuel and a normal load of hydraulic fluid. Figure 27 shows the forward fuselage of the first test aircraft. Note the almost perfect accordion effect from the wall impact.
